Method Statement for the dismantling and storage of the Bicycle Mural – Stantonbury, Milton Keynes

CLIENT – Aldi Stores Ltd

Project Name: Stantonbury Bicycle Tile Mural

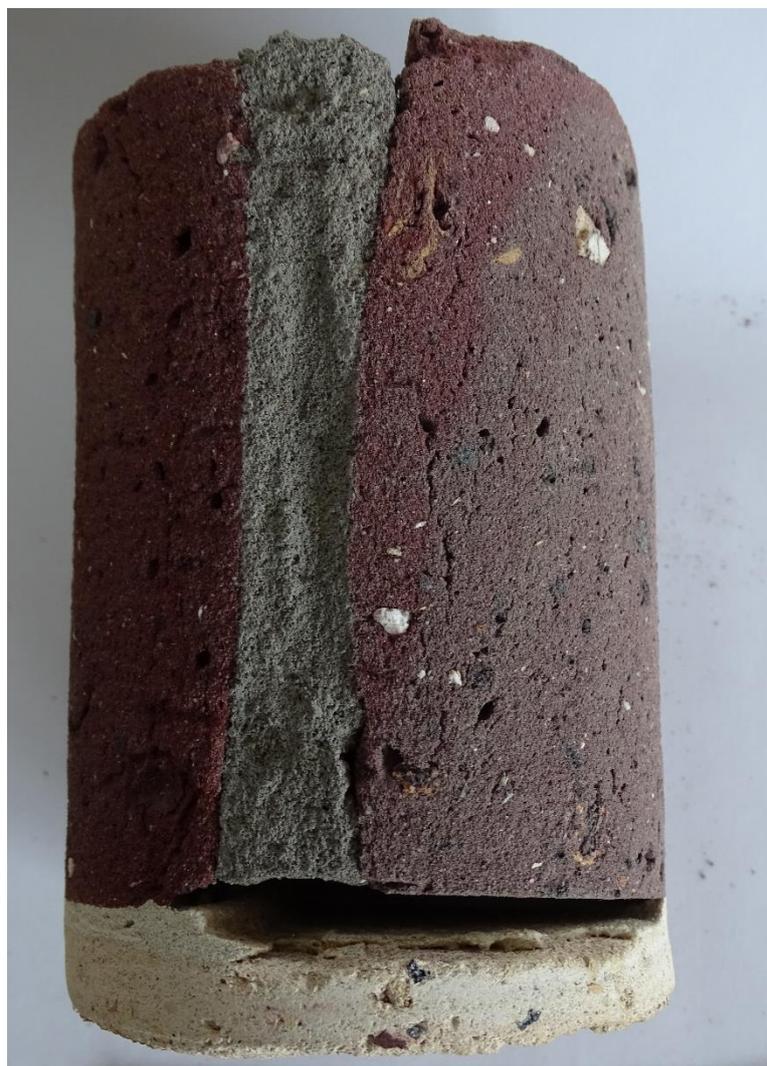
Figure 5 Core sample, demonstrating inconsistency of tile adhesive application.

Diameter		8cm
Total depth of core consisting of:		11.5 cm
	brick	10cm
	tile	0.75cm
	tile adhesive	0.75cm

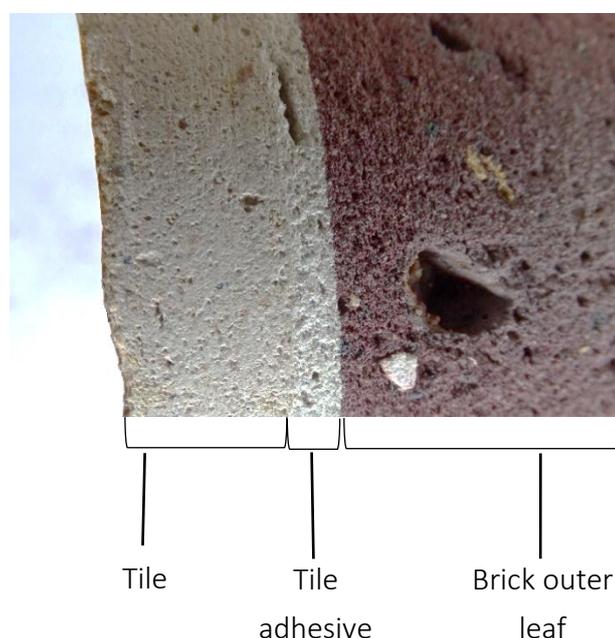
Figure 6 Macro photograph showing the tile and substrate

The core sample consists of the tile, tile adhesive and brick outer leaf, see Figure 6, observations of it enable conclusions to be drawn about the body type and glaze layers.

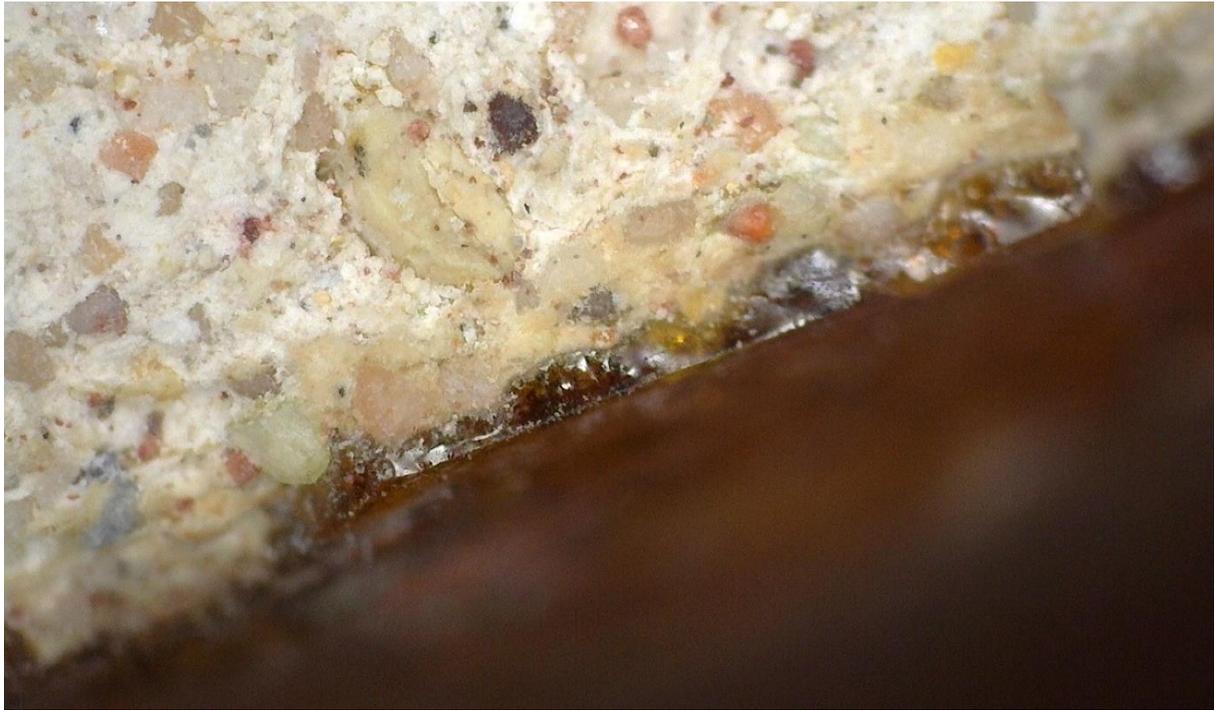
Figure 7 Dino-Lite image of the defined glaze layer on the body of the tile x153 magnification.

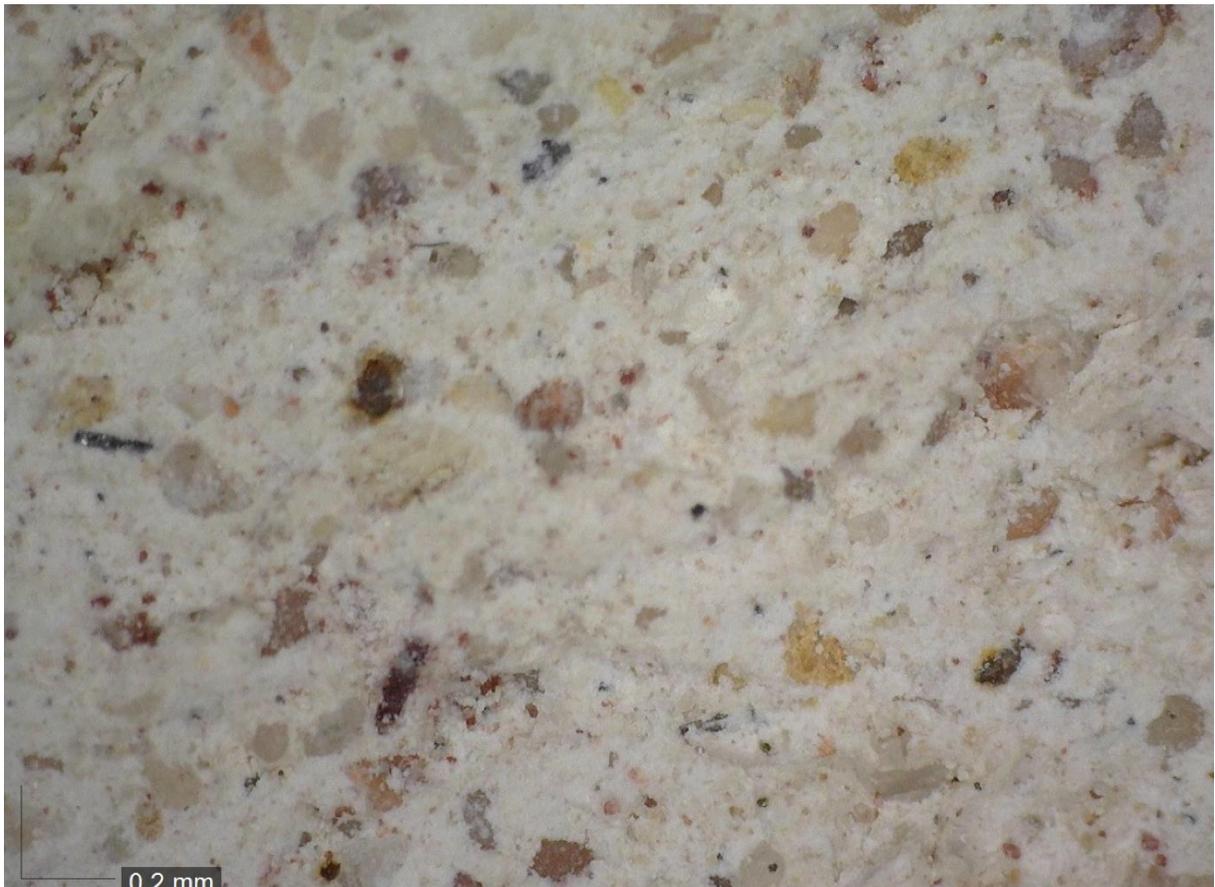
The body of the tile is buff coloured and shows a variety of small coloured inclusions and air pockets, see Figure 8. These indicate that the tiles are earthenware and are likely to have greater than 5% porosity, this porosity can be clearly observed in Figure 6. It is probable that the clay body would have been formed and then biscuit fired, the glaze would then have been applied and a glaze firing up to 1100° would have been carried out. The glaze is gloss and translucent and shows a distinct layer from the body of the tiles, see Figure 7 (Buys & Oakley, 1993). These observations support some of the background research already gathered as to the stages of manufacture (see section 0).

Figure 8 Body of tile taken with Dino-lite at 153x magnification

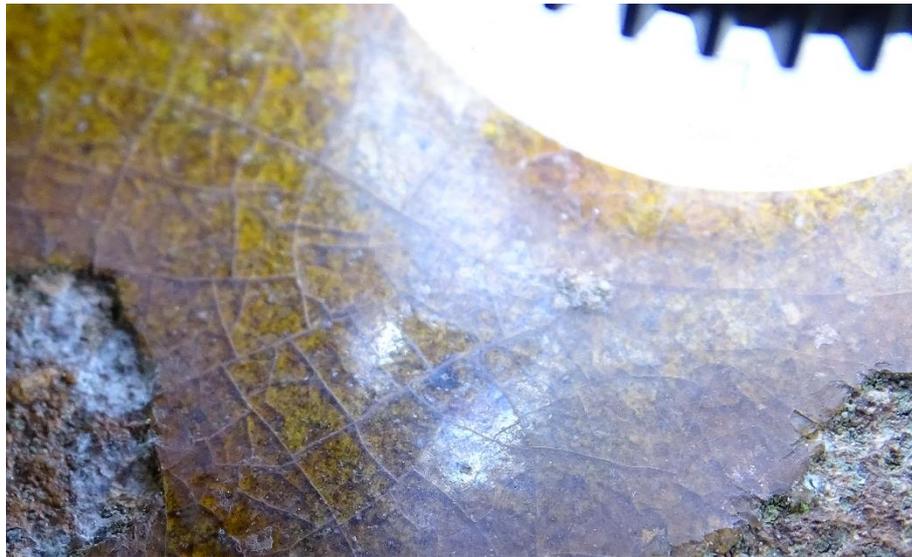
The glaze fit is tenuous with signs of cracking and weak adhesion to the substrate, this crazing occurs due the different strains between the body and the glaze during firing and cooling, Figure 9. The edges of the crack structure appear to be quite sharp, indicating that this occurred to the gaze after it had set. This crack structure provides points of access for soluble salts to the surface.

Figure 9 Macro photograph demonstrating the crack structure of the glaze.

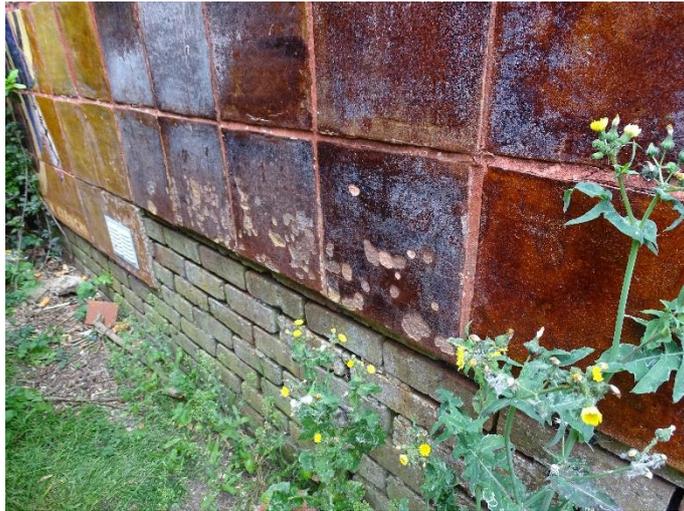
There were some areas of deterioration of the glazed surface, it is likely that this is due to the presence of soluble salts which were noticeable on the face of the tiles to the lower two thirds of the mural, concentrated in white patches that follow the crack structure of the tile. The source of these salts is unknown at this point and could be from the tile body or substrate, further testing would provide more conclusive results. The recrystallisation of these salts from within the body of the structure has consequently led to the spalling of glazes on the surface. This deterioration to the surface of the tiles seems to be a combination of efflorescence see Figure 12 and sub efflorescence see Figure 10 and Figure 11, the later creating the most damaging effects on the surface (Torraca, 2009). The wall is south facing and therefore likely to achieve a higher heat gain and faster evaporation of water from the surface.

Figure 10 Spalling of brown glaze to lower section of the wall with efflorescence above.

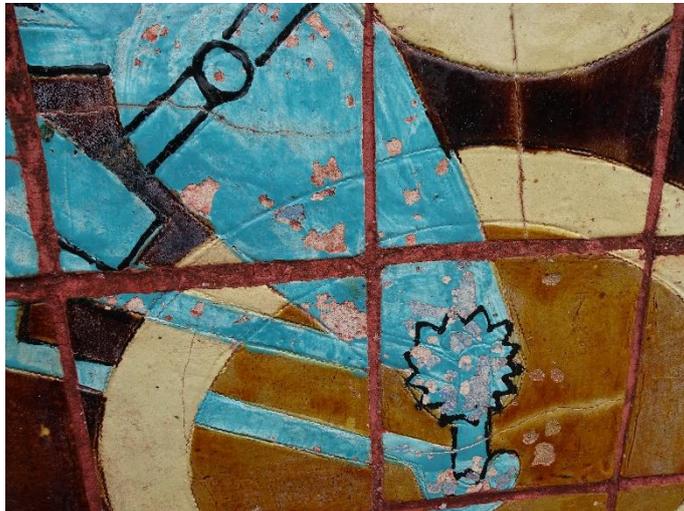
Figure 11 Spalling of blue glaze in the lower mid-section of the wall

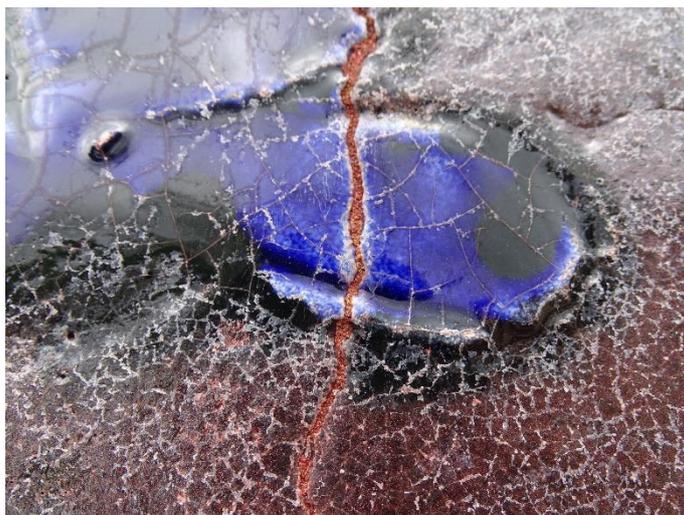
Firing cracks to the glaze surface was noted in places see Figure 12.

Figure 12 Appearance of soluble salts on the surface of the tile, also showing firing crack to the glaze. rounded edges demonstrate it took place before the glaze had set

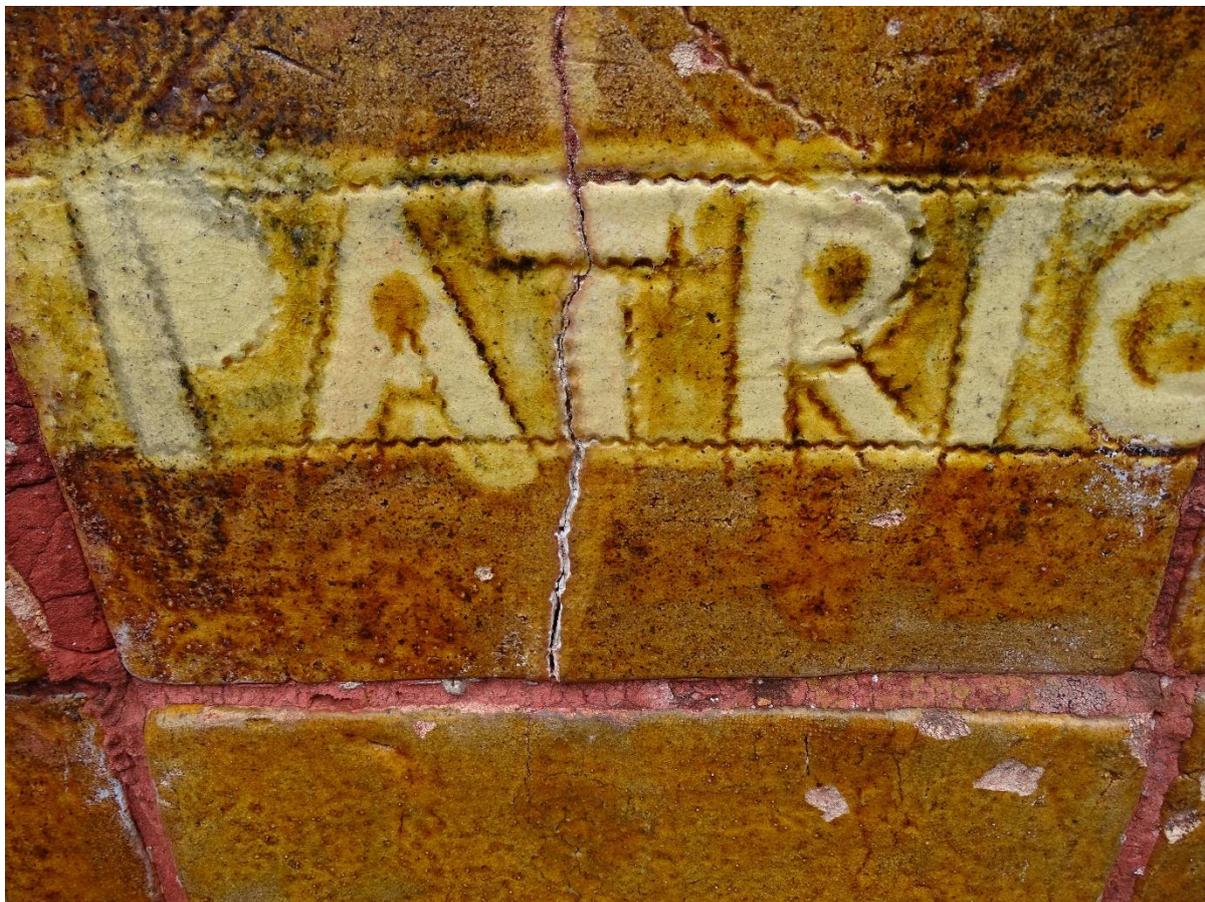
A number of tiles have firing faults in the form of splits through the body of the tile see Figure 13, these are classed as manufacturing defects rather than as deterioration however, they are weak points in the scheme and allow water ingress (Hamilton, 1978).

Figure 13 Deeper firing crack through the body

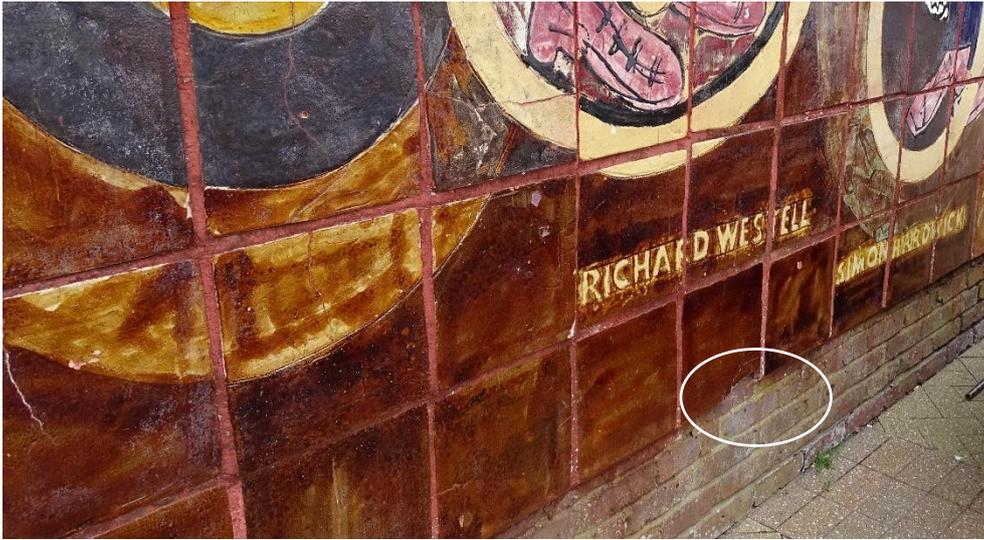
The tiles in general, appeared to be structurally sound, and percussive testing suggested that the adhesion between the tiles and substrate was generally good in the areas tested however, only a relatively small area was tested due to access. Some small losses to the outside edges of the scheme were noted, although these were few, see Figure 14.

Figure 14 Loss to edge, ringed in white

Further conservation work should at least consist of the removal of the front facings, and cleaning of the tile surface. There are small amounts of loss to the outside edges of the tiles, these should be addressed once the tiles have been relocated in a compatible material with these areas retouched to match the original colour scheme. It is assumed that any losses will be those recorded before facings were applied. There may be small losses during the relocation process, but it is not anticipated that wide scale damage is likely if the work is carried out under the supervision of specialist contractors.

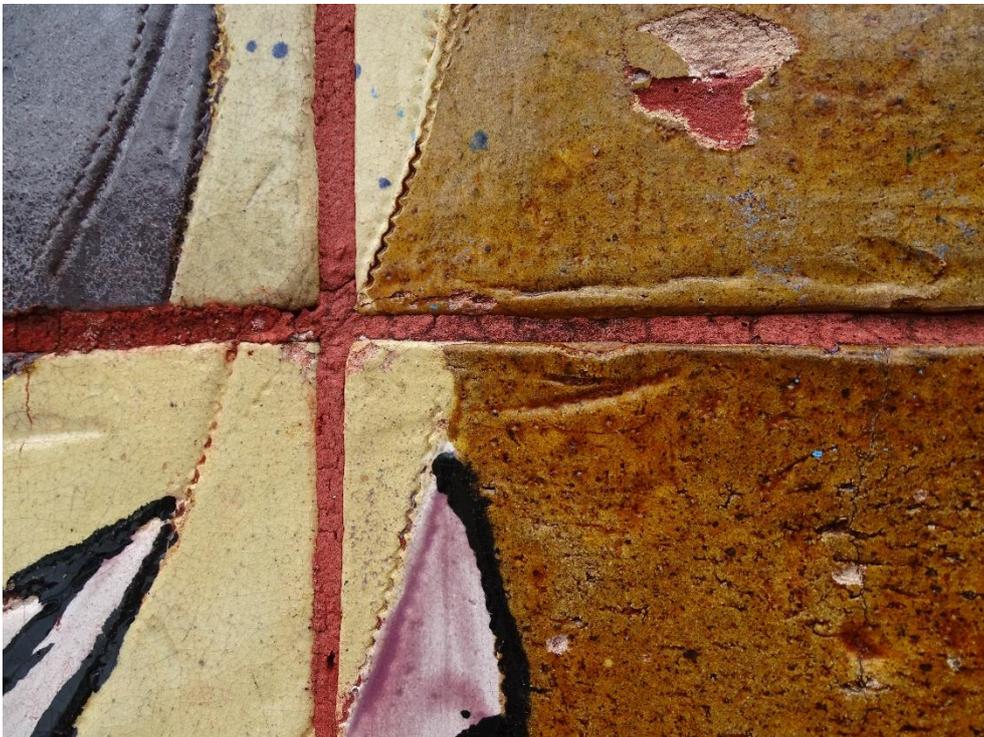
The mortar joints around the tiles appear to be structurally sound with little loss, however they show a crack structure, see Figure 15.

Figure 15 Detail of mortar joints
