General Purposes Committee

Management Asbestos Survey
Of
The Community Hub,
24 Mercers Drive, Bradville
Milton Keynes, Bucks, MK13 7AY

Asbestos Reinspection Survey

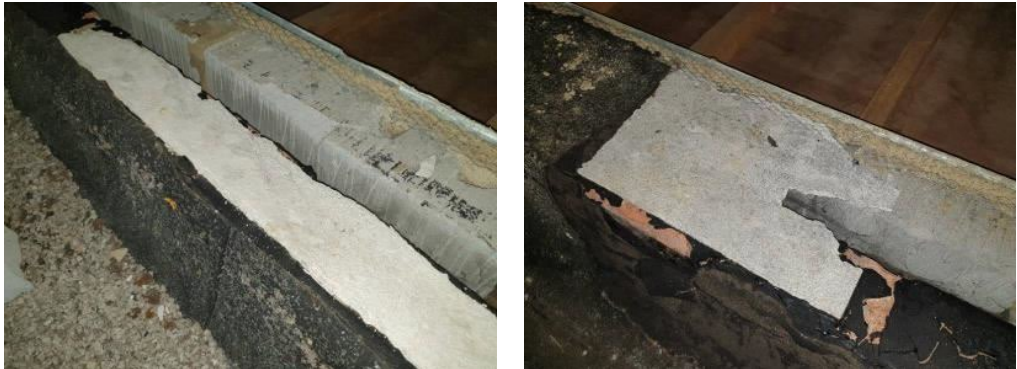
Location		Material location & description
Building:	Main Building	Panels lining parapet walls of old flat roof

Floor:	Roof Void	
Room:	R0/001	
Form:	Insulating Board Products	
Sample Ref:	ACMS184/002	
Extent:	100 lin m

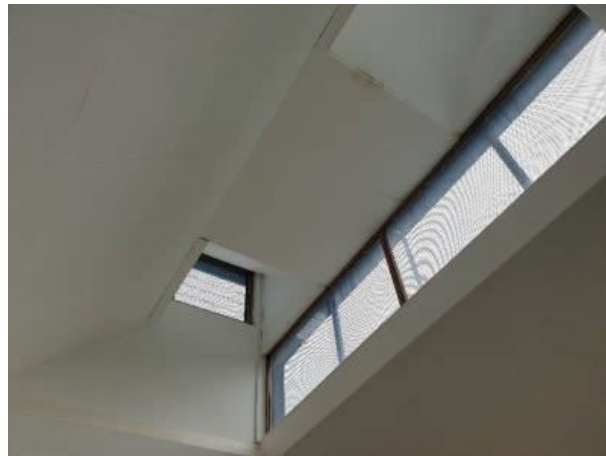
Building:	Main Building	Form:	
Floor:	Ground Floor		
Room Ref:	0/002 Council Chambers	Extent:	
Location & Description:	No safe access to inspect high level ceiling and associated windows (Over 4 metres)	Sample Type:	
		Sample Ref:

Management Recommendation	Action Date
<i>Non-accessed area. This area should be regarded as containing asbestos until assessed by a competent person.</i>	Before Works

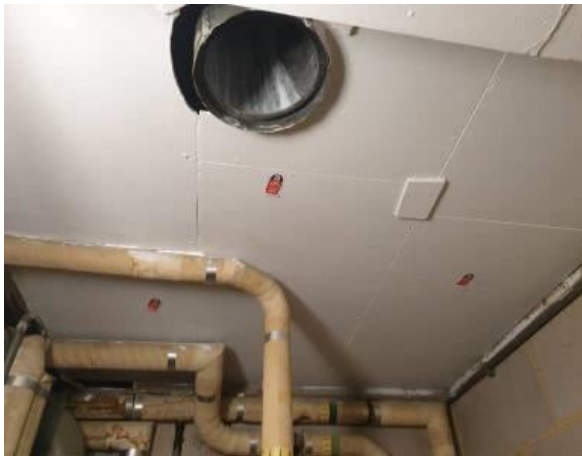
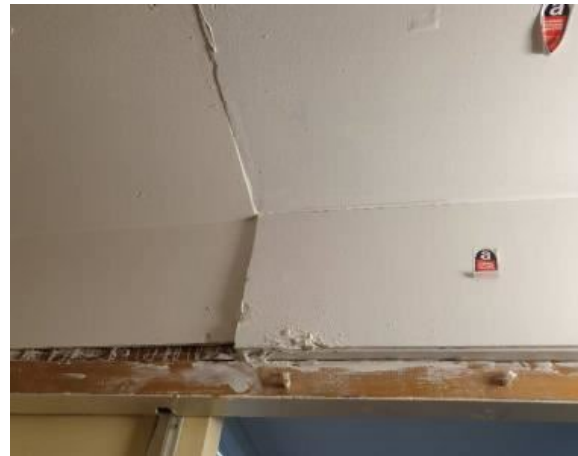
Building:	Main Building	Form:	Insulating Board Products
Floor:	Ground Floor		
Room Ref:	0/009 Boiler Room	Extent:	2 sqm
Location & Description:	Panels lining ceiling and wall above door	Sample Type:	Taken
		Sample Ref:	ACMS1034A/001

Analysis Result	Amosite	Assessment Date:	18/05/2023
		Assessed By:	James Molloy
Material Assessment			
Product Type	Damage/ Deterioration	Surface Treatment	Asbestos Type
2	1	1	2

Total Scores			
Material Risk	Priority Risk	Combined Risk	Risk Category
6	3	9	D

Management Recommendation	Action Date
<i>Re-inspect at recommended intervals.</i>	17/05/2024

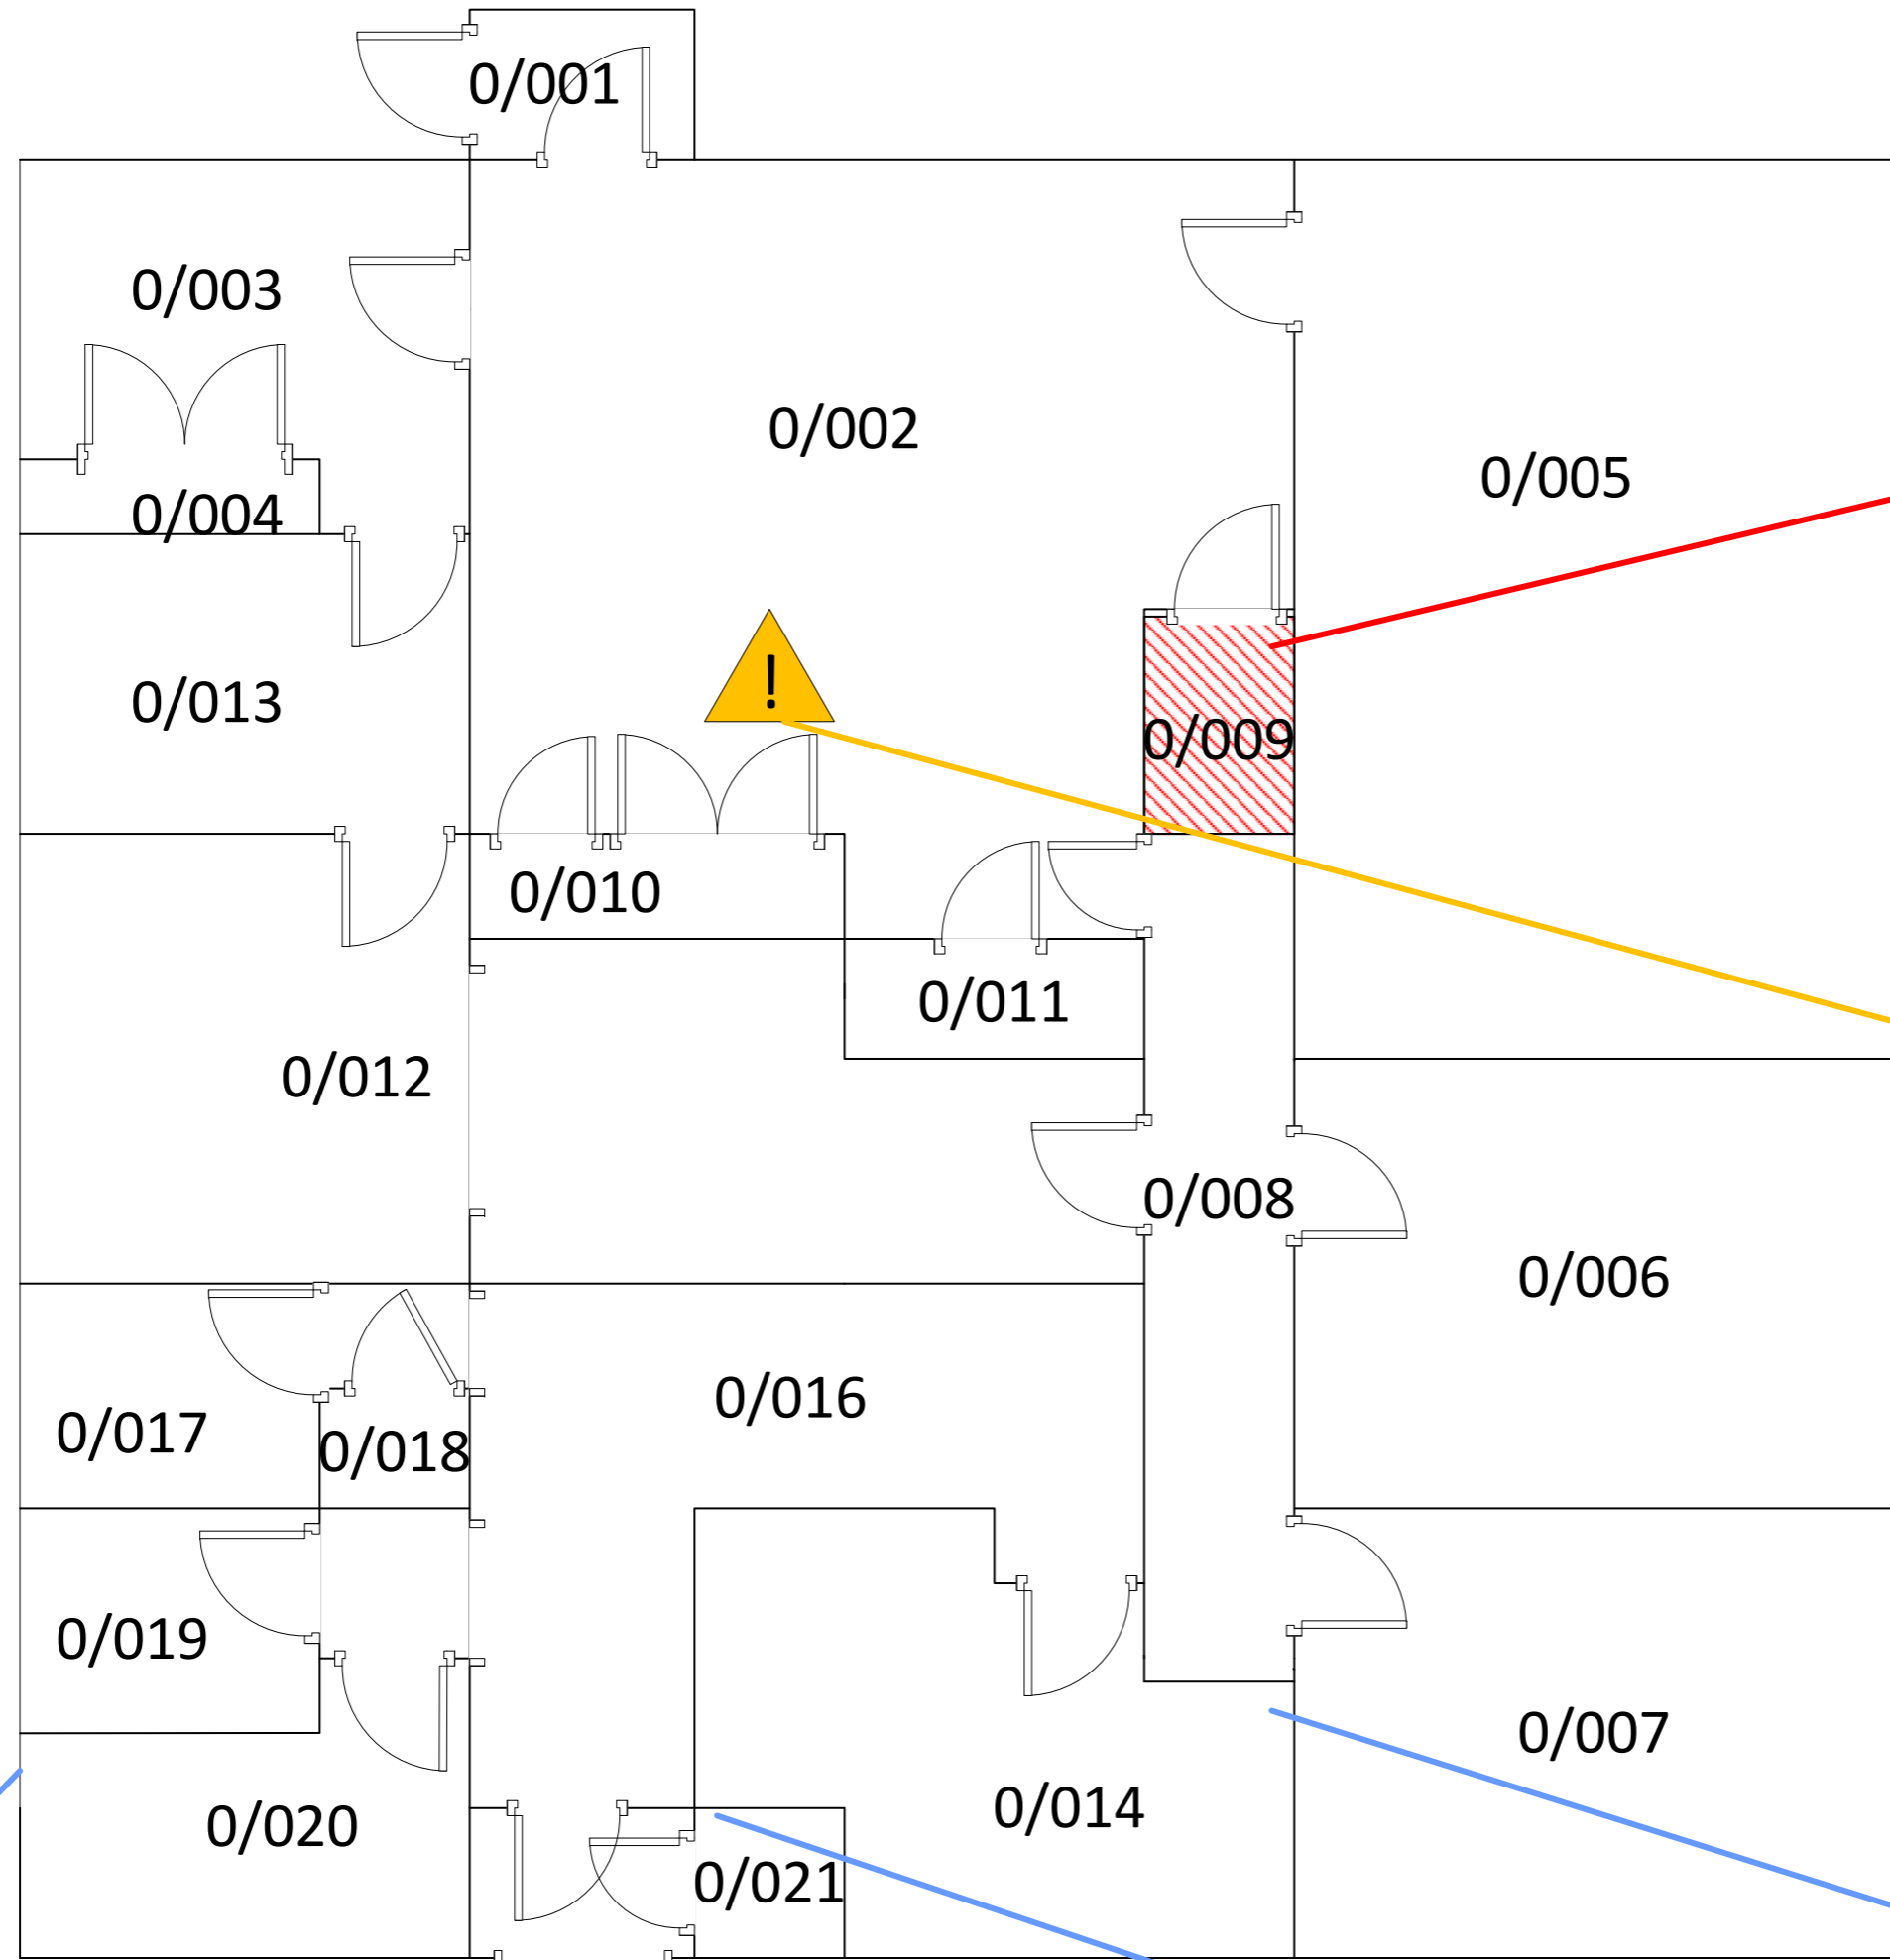
ACMS1034A/001
Panels lining ceiling

No access to inspect high level ceiling

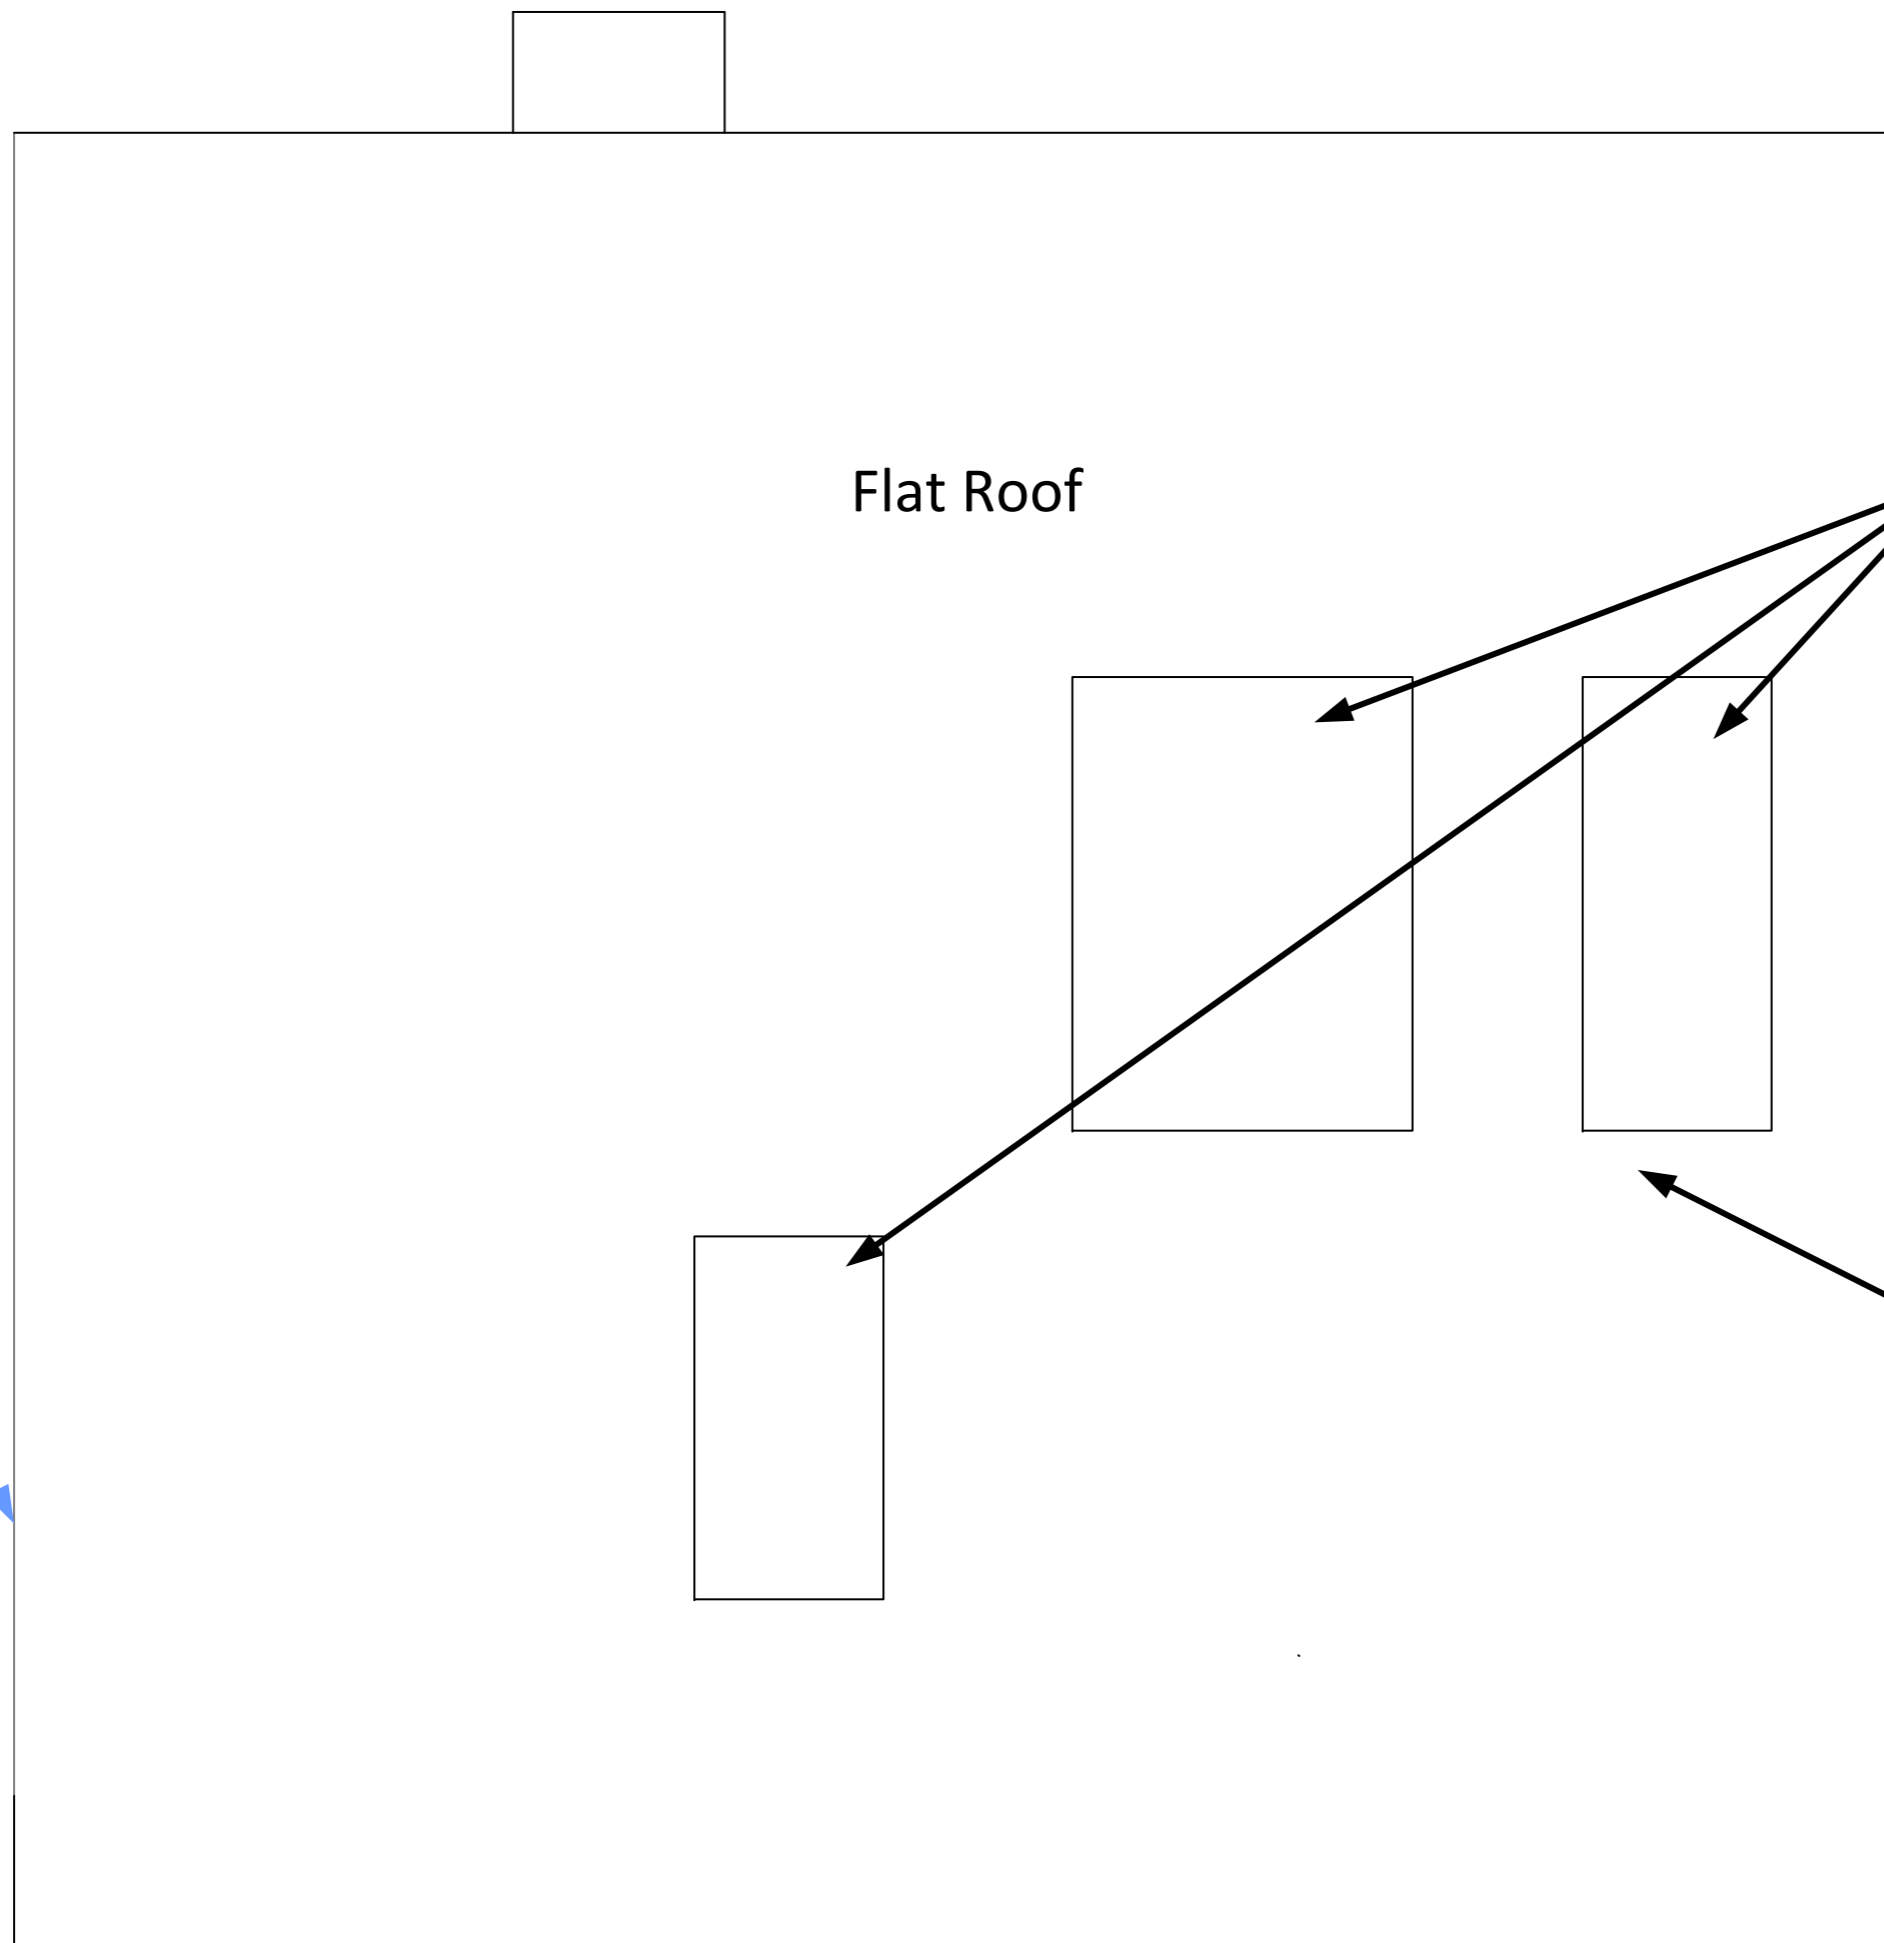
ACMS1034B/004
Damp Proof
Membrane

Visual
Cement Roof
Tiles
(Removed)

ACRE1124A/
001
Roof Tile
Fragments
(Removed)

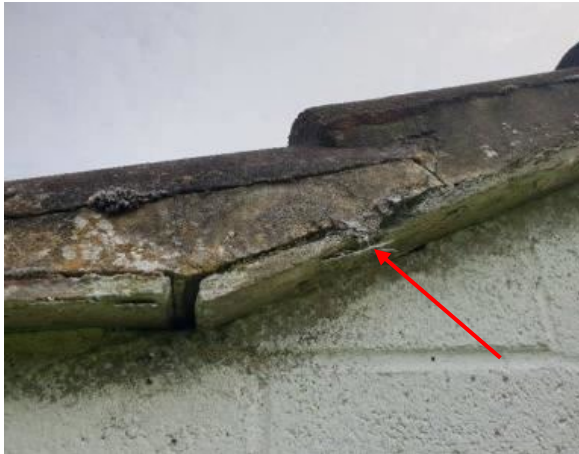
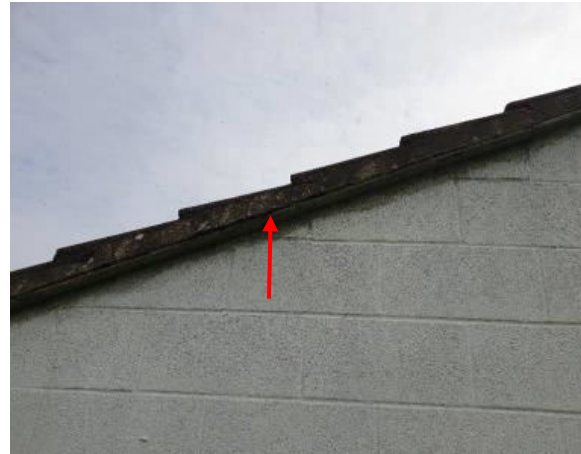
Analysis Result	Amosite, Chrysotile	Assessment Date:	18/05/2023
		Assessed By:	James Molloy

Material Assessment			
Product Type	Damage/ Deterioration	Surface Treatment	Asbestos Type
1	2	1	2

Total Scores			
Material Risk	Priority Risk	Combined Risk	Risk Category
6	1	7	D
