Minutes of the **General Purposes Committee Meeting** held on **Wednesday 6th September 2023** at **11.30am** at Stantonbury Parish Office, 126 Kingsfold, Bradville, Milton Keynes, MK13 7DX.

BUILDING INSPECTION: Wylie Building

In accordance with your specific instructions, we carried out a survey of the undermentioned parts of Stantonbury Parish Council, 126 Kingsfold, Bradville, Milton Keynes , Buckinghamshire, MK13 7DX on the 24th November 2023. Our findings and recommendations are set out below and should be read in conjunction with the enclosed General Notes for clients and Health and Safety precautions.

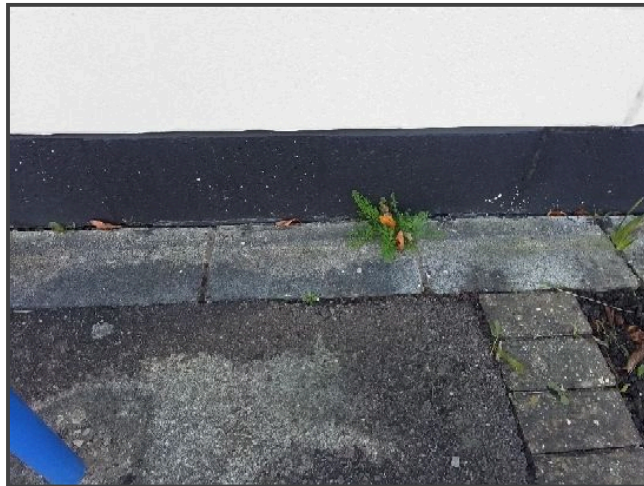
- The external ground level is too high with respect to the existing damp proof course and should be lowered so that the damp proof course is at least 150mm above external ground level. Doing this will prevent ponding and splashback which may allow damp to penetrate the buildings fabric.

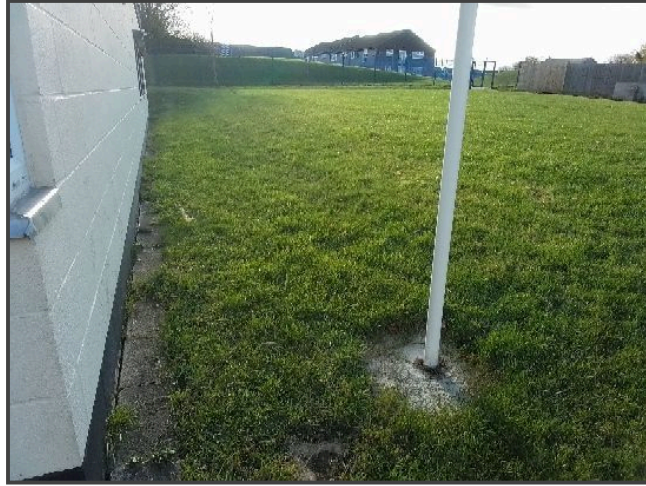
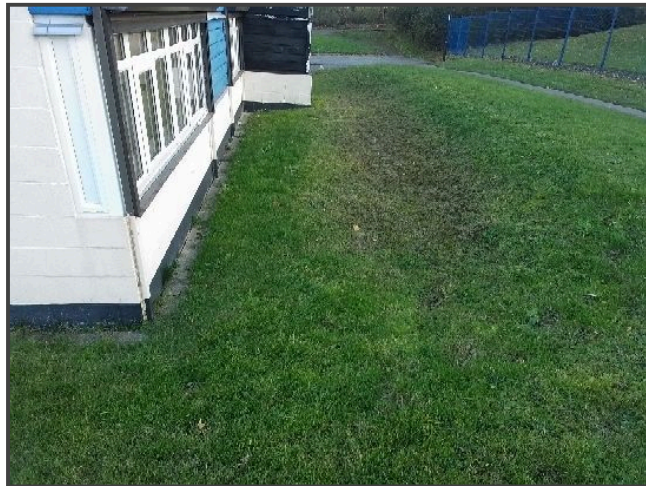
- At the rear and right hand side external elevations, it appears that the ground level slopes towards the property, meaning any heavy rainfall will penetrate the buildings fabric. It is recommended that your own contractor installs a suitable drainage system to prevent this rainwater being able to penetrate the buildings fabric. No allowance has been made by Rentokil for this work.

- Your own contractor to check and maintain/repair as necessary all gutters, downpipes, external joinery timbers and roof coverings. No Allowance has been made by Rentokil for this work.

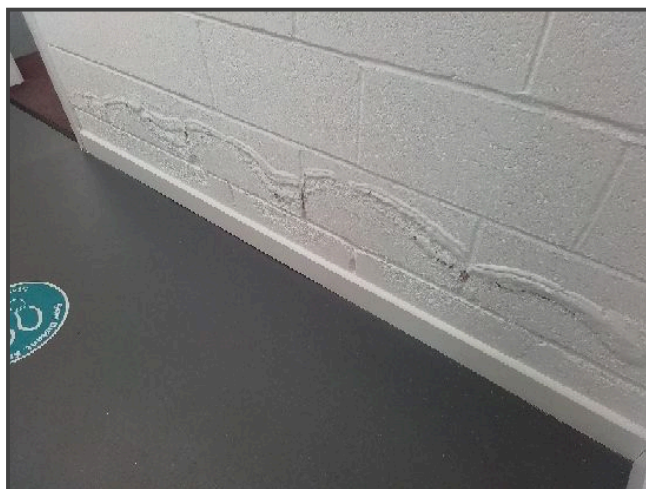
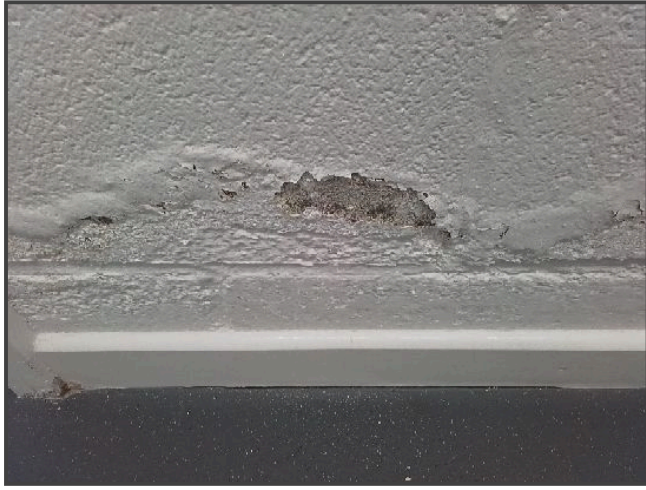
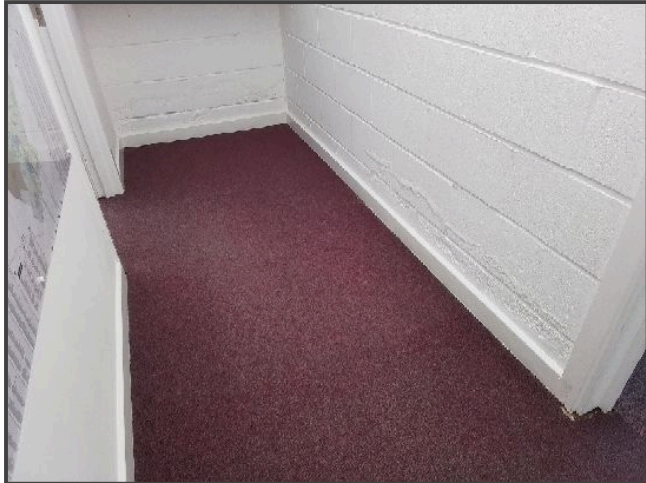
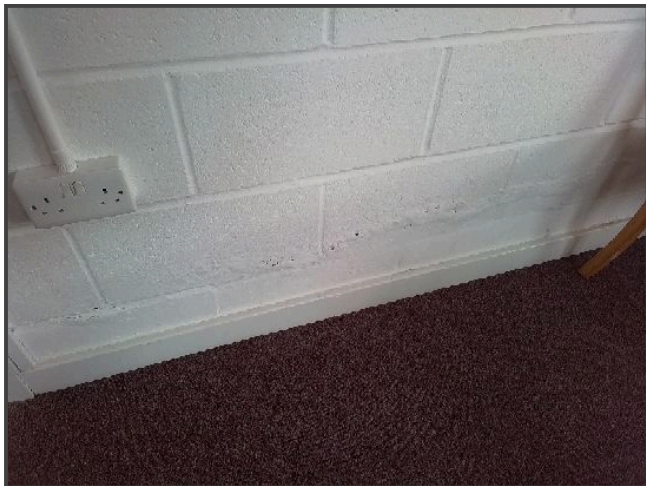
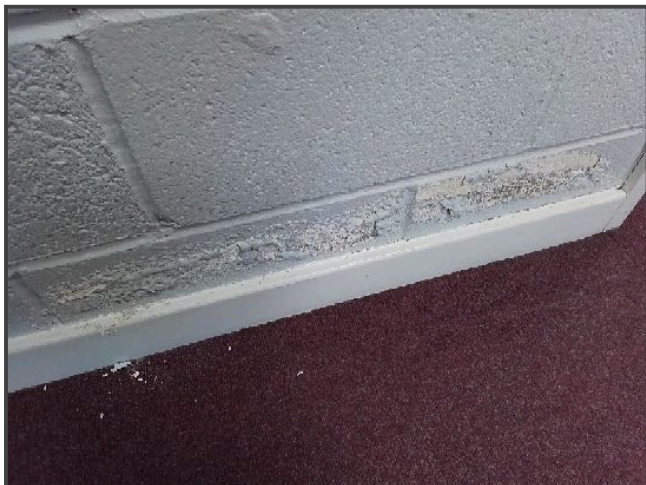
- There is visual evidence of salt banding on the internal and external walls.

Salt bands occur following a previous leak, and is a sign that the walls are drying out.

Rentokil are unable to categorically state the route cause of the moisture at this time.

- No specialist treatment required on the basis of this inspection.
- It is recommended that your own contractor investigates any potential leak issues and repairs it as appropriate. No allowance has been made by Rentokil for this work.
- It is recommended that your own contractor removes the existing paint to allow the wall to breathe.

Following this, it is recommended that your own contractor redecorates the areas.

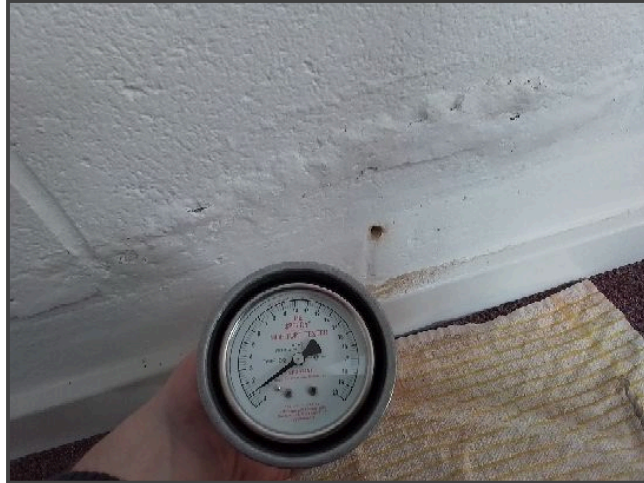
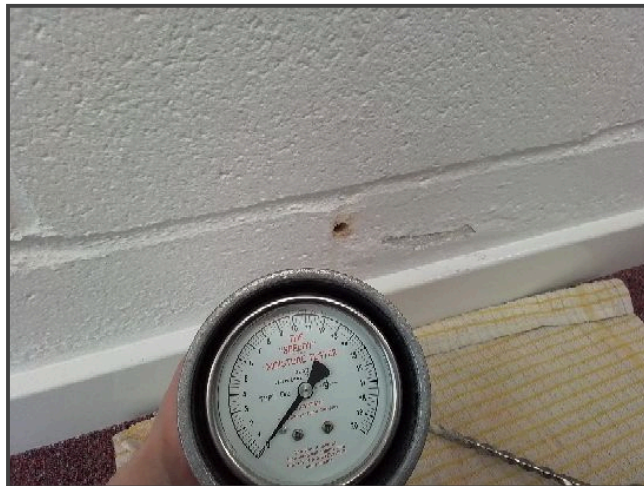
- At the time of survey, a calcium carbide test was carried out to the wall an

internal wall in the rear room right, and to an external wall in the rear room right.

When conducting a calcium carbide test we test for the wet weight from within the fabric of the wall. Readings of above 5% wet weight would indicate high moisture content.

A sample was taken from the mortar bed and readings of 1% or less wet weight were recorded in both areas, which indicated that there is not an issue of rising damp or penetrating dampness within this area.
