Method Statement for the dismantling and storage of the Bicycle Mural – Stantonbury, Milton Keynes

CLIENT – Aldi Stores Ltd

Project Name: Stantonbury Bicycle Tile Mural

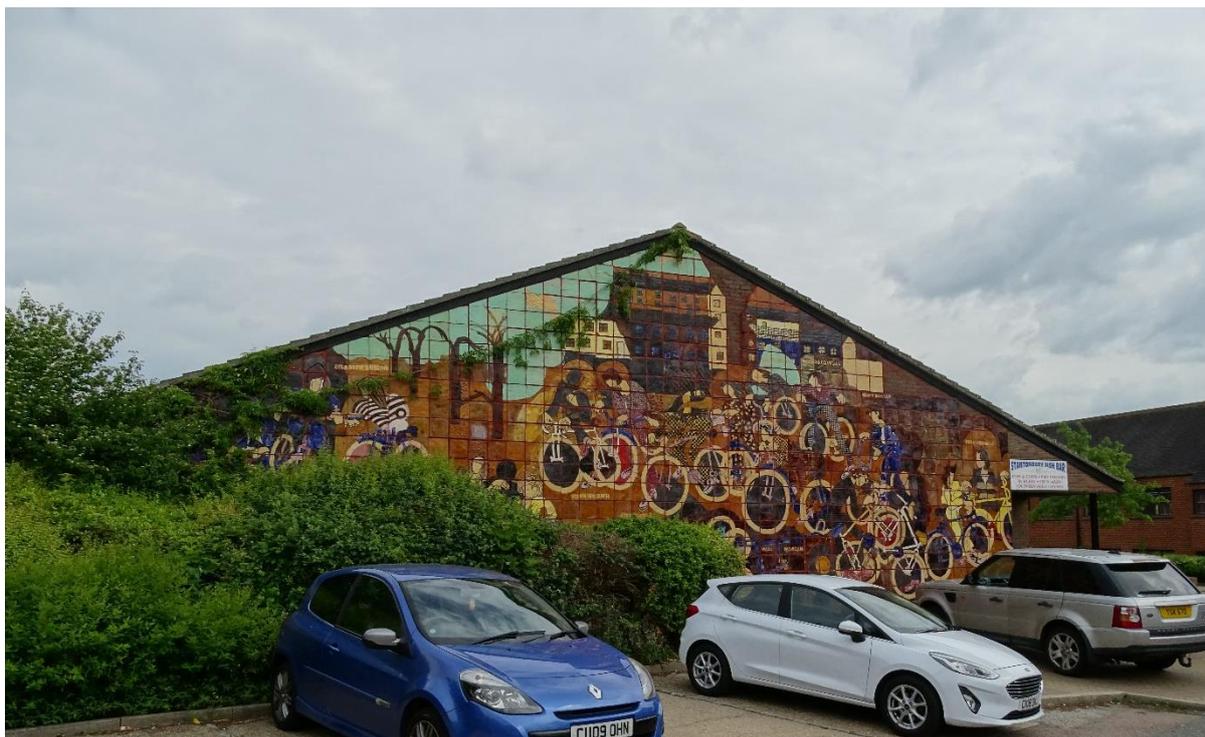
Figure 1 View of the whole Bicycle Mural during site visit

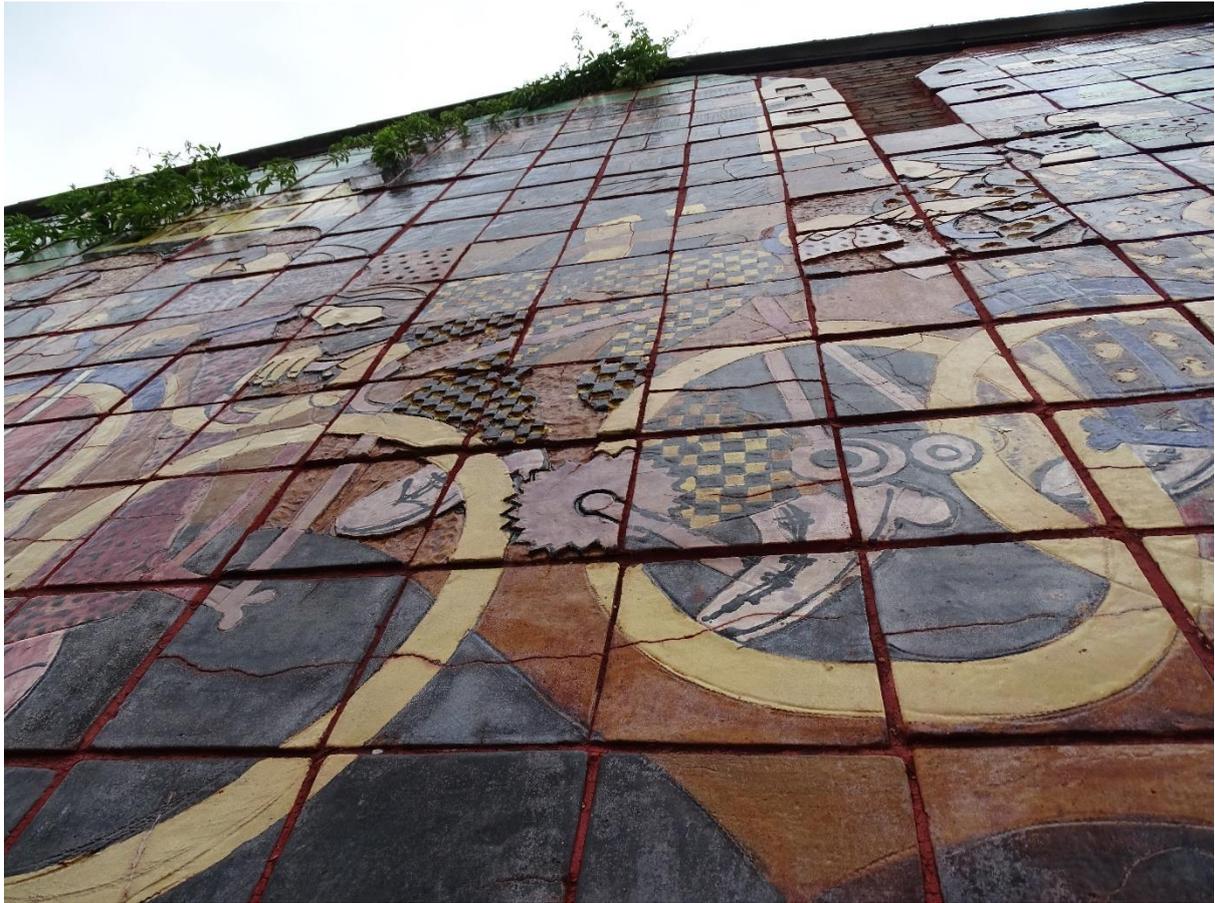
Figure 2 Central section of the mural showing the relief on the tile surface

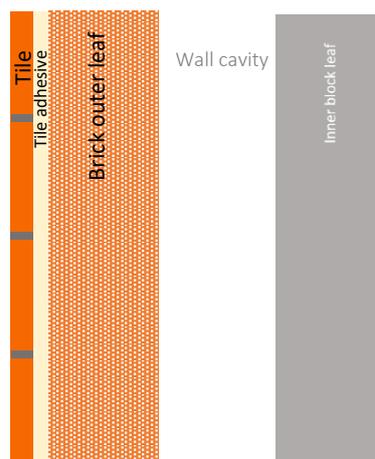
The substrate comprises a brick outer leaf of a cavity wall onto which the tile is adhered, see Figure 4. The adhesive is unknown but is relatively soft following observations of the core sample. It should be noted however, that while it is possible a proprietary adhesive was used, there could be varying degrees of strength and application across the whole area.

Figure 4 Diagram to indicate the construction of the wall

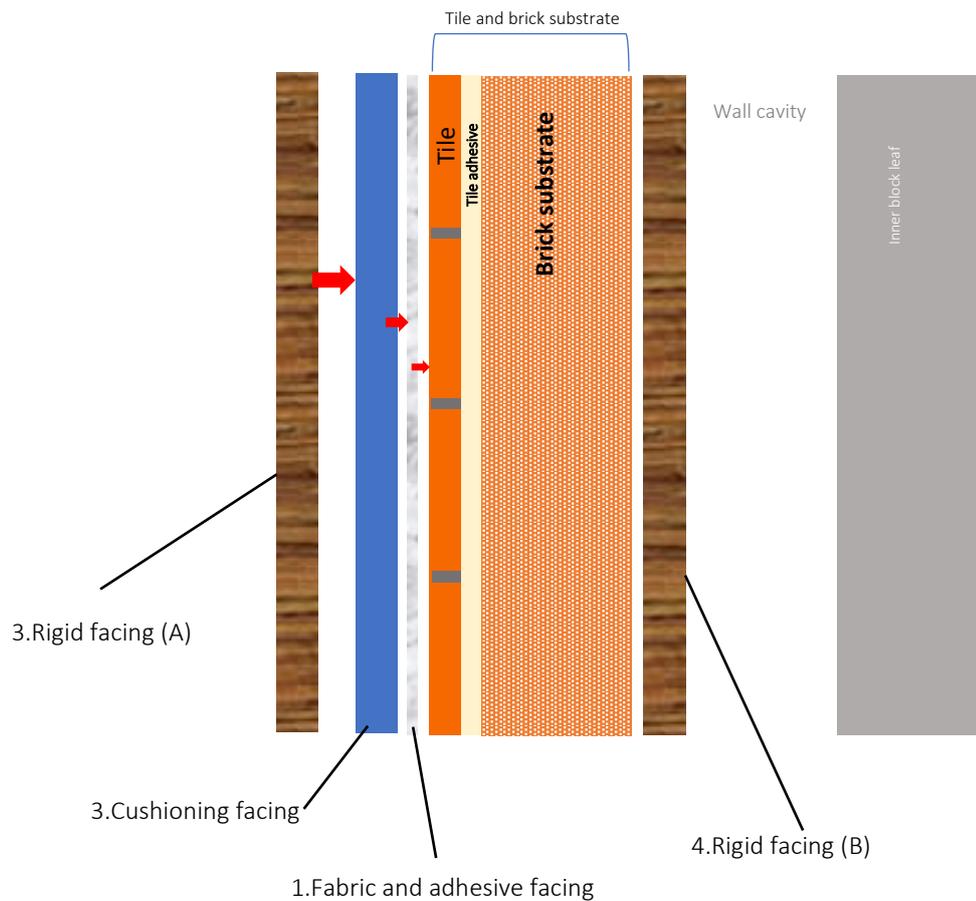
Figure 16 Diagram to show levels of application of the facings

The application of facings to the front of the tiled surface and to the rear of the brick outer leaf will ensure that during the cutting and lifting process, the tiles will remain secure. See Figure 16 to visualise the layers of facings. It is anticipated that the tiles be removed in approximately 4x4 sections where possible, this equates to panels just bigger than 1m², further guidance from a structural engineer should be sought to confirm this. These sections should be mapped before the facings are applied and a gap left in the grout line between sections. This will allow for cutting of the sections once the direct fabric and cushioning facing has been completed.

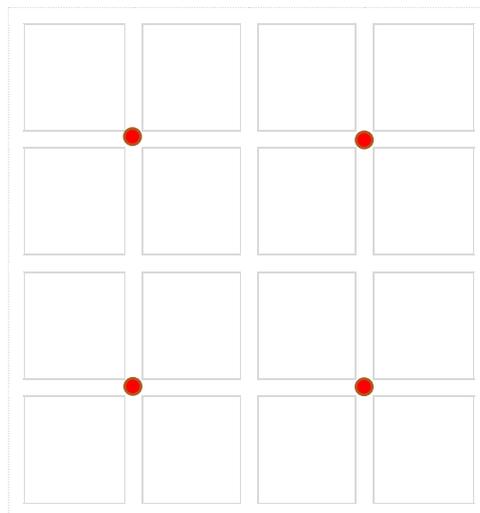
Figure 17 Representation of a 4x4 grid of tiles and positioning of stainless-steel threaded rods in red

Before the rigid facing is applied, holes should be drilled at the intersection of grout lines to receive stainless steel threaded rods, see Figure 17. These should be planned beforehand.

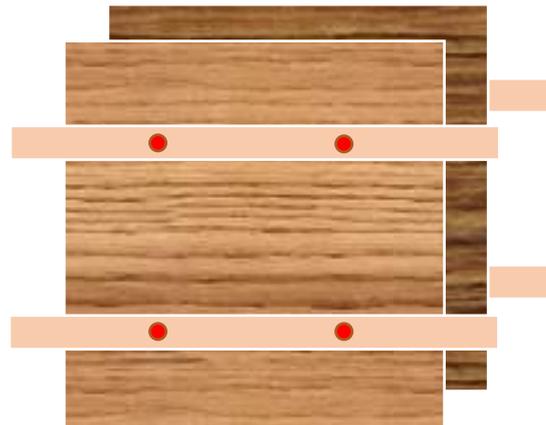
Figure 19 Diagram to show batten position in relation to the mural section and stainless steel threaded rods

A sheet of marine plywood should be pre-cut to the exact dimensions of the tile panel with holes to accept the rods, front and back. The plywood sheets should be applied to the mural face (A) and lowered into the cavity behind (B) see Figure 16 and the threaded rods pushed through, wall ties should be cut as necessary. Timber battens should be placed over the threaded rods and tightened into position with washers and nuts. These battens have a two-fold purpose of applying pressure to hold all the layers in place and enable handing and movement, see Figure 19 and Figure 18.

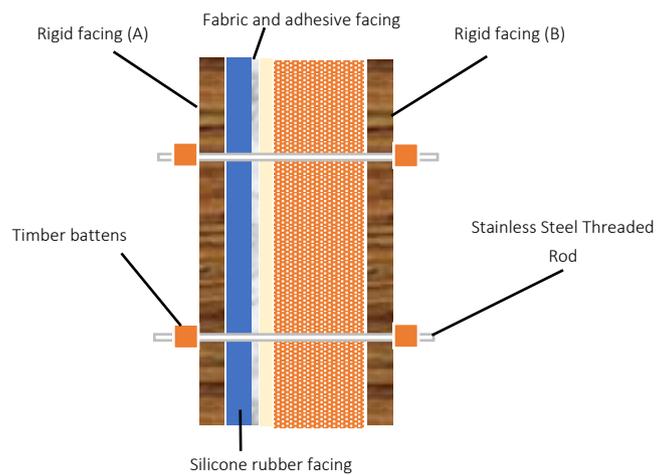
Figure 18 Diagram to show a faced section held with rigid facings, stainless steel threaded rod and timber battens.

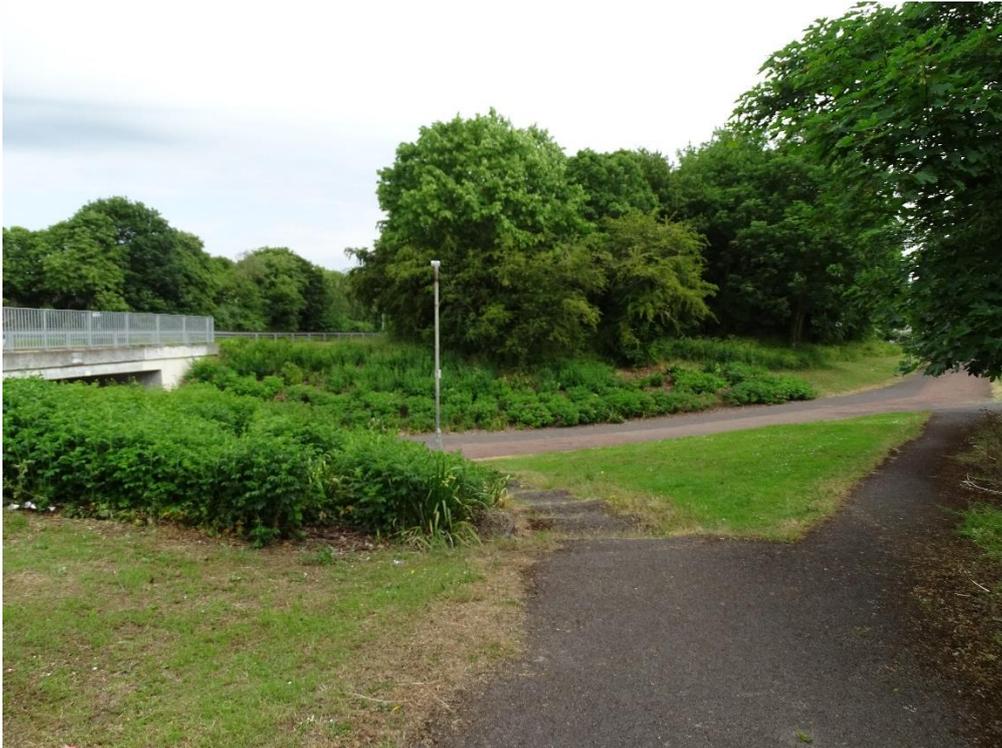
Figure 20 Proposed new location of the mural

The location for the mural is close to the original site and therefore acknowledges the community values that this mural represents, to an extent. The site is close to the subway and the mural has the potential to be seen from the road. Within the site, however, it is awkwardly positioned behind trees and away from the main public entrance to the new building.
