Minutes of the **General Purposes Committee Meeting** held on **Wednesday 6th September 2023** at **11.30am** at Stantonbury Parish Office, 126 Kingsfold, Bradville, Milton Keynes, MK13 7DX.

BUILDING INSPECTION: Wylie Building

In accordance with your specific instructions, we carried out a survey of the undermentioned parts of Stantonbury Parish Council, 126 Kingsfold, Bradville, Milton Keynes , Buckinghamshire, MK13 7DX on the 24th November 2023. Our findings and recommendations are set out below and should be read in conjunction with the enclosed General Notes for clients and Health and Safety precautions.

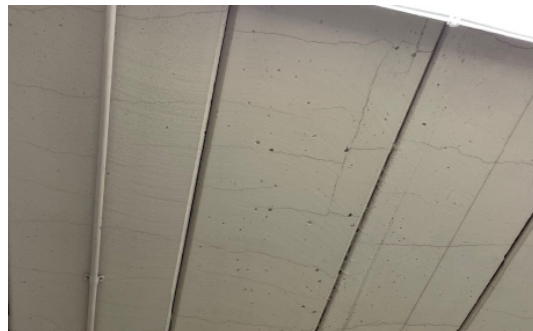
Figure 7: Underside of a cracked RAAC panel

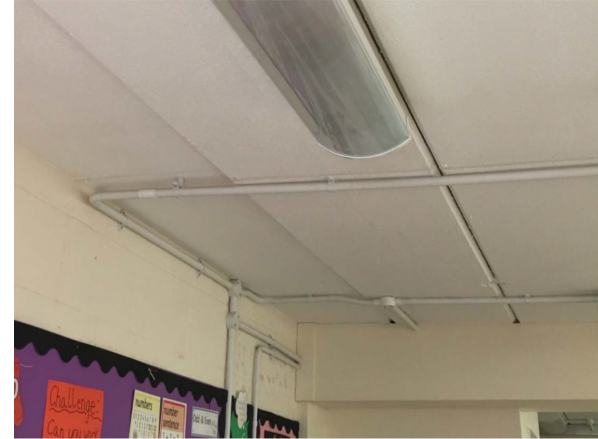
RAAC panels may bow or deflect. From the underside of the roof or floor you may see a 'gap' between two adjacent panels.

Figure 10: Example of deflected RAAC panel

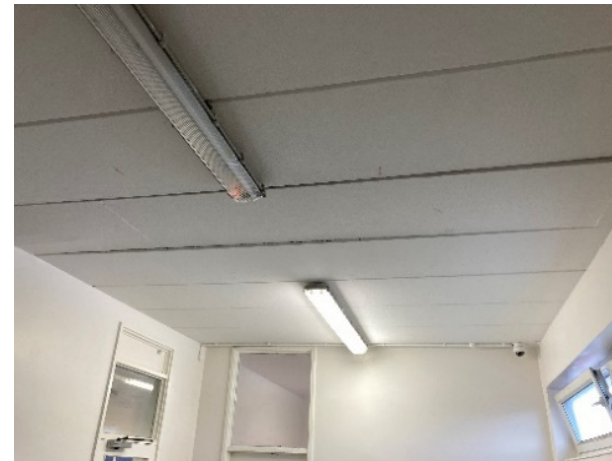
Figure 11: Example of deflected RAAC panel

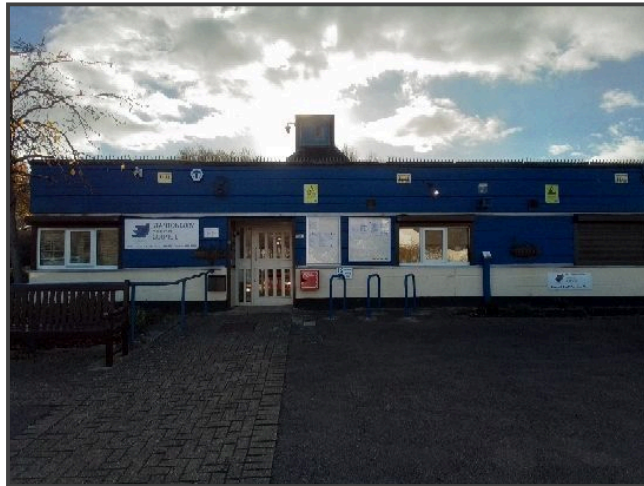
- A damp proof course could not be identified due to the painted external block work.

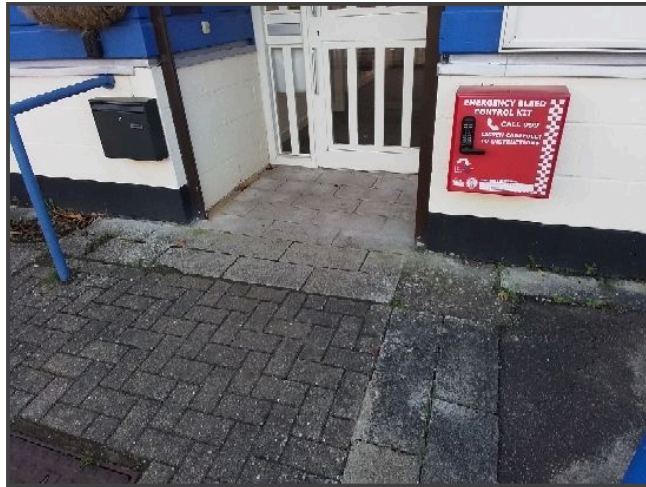
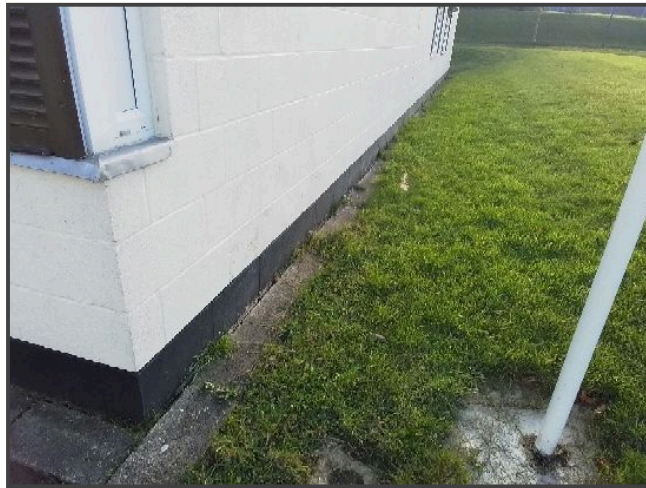
- There are no external air vents in the external walls due to the internal floors being solid construction.

- At the rear and right hand side external elevations, it appears that the ground level slopes towards the property, meaning any heavy rainfall will penetrate the buildings fabric. It is recommended that your own contractor installs a suitable drainage system to prevent this rainwater being able to penetrate the buildings fabric. No allowance has been made by Rentokil for this work.

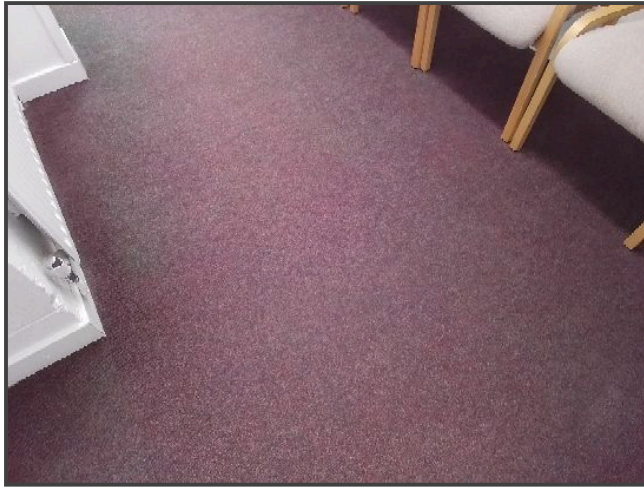
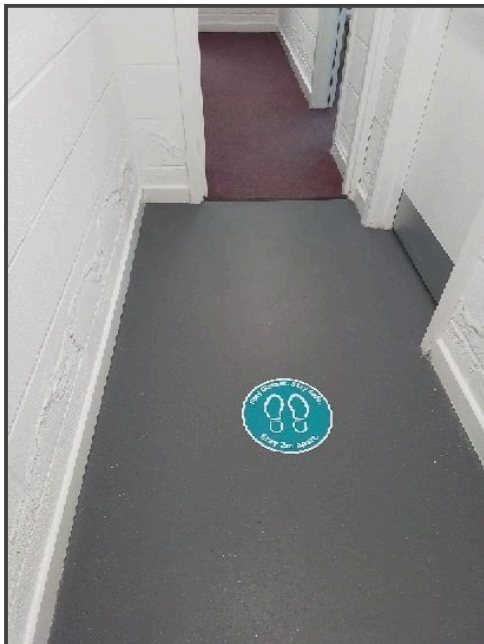
- The floor is of a solid construction and is not included in our survey.
- The testing of solid floors to determine the presence and effectiveness of a suitable damp proof membrane falls outside the scope of our inspection due to the necessity for destructive drilling of the floor slab. We are therefore unable to give any warranty as to condition or performance of this element.

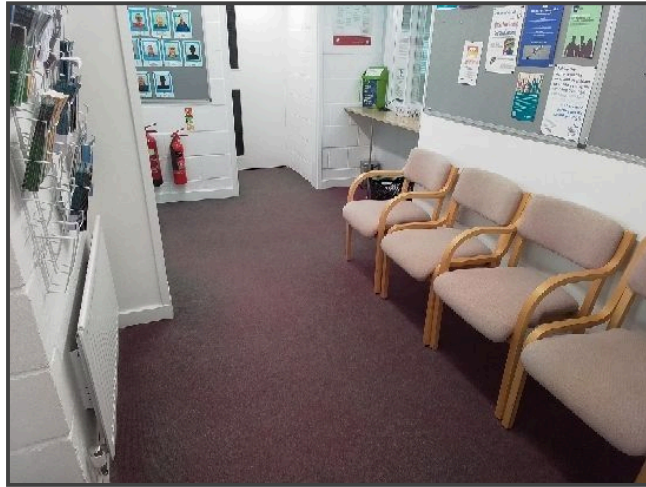
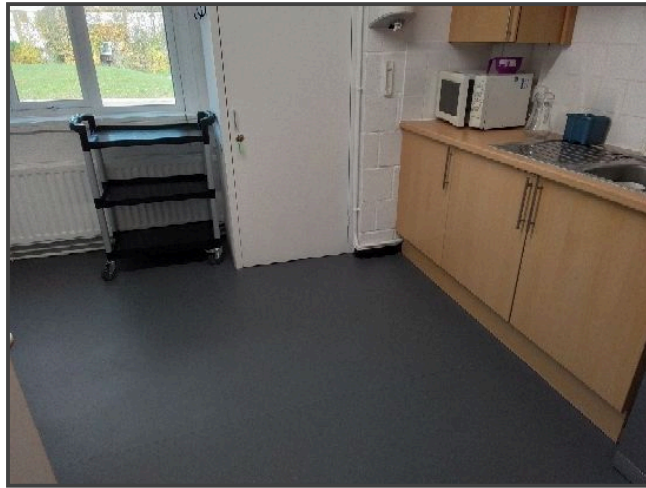
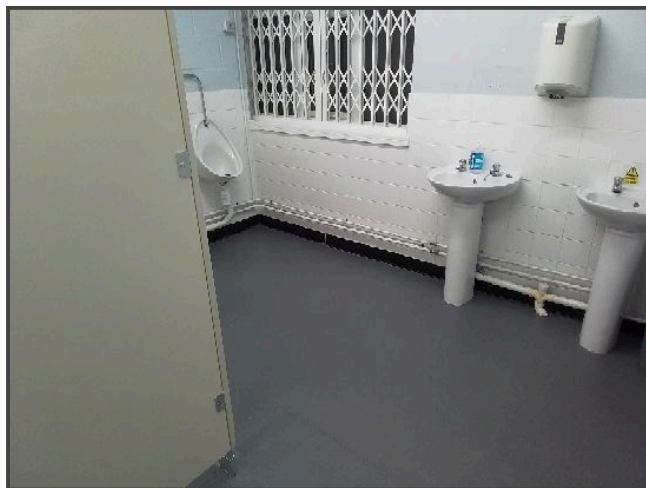
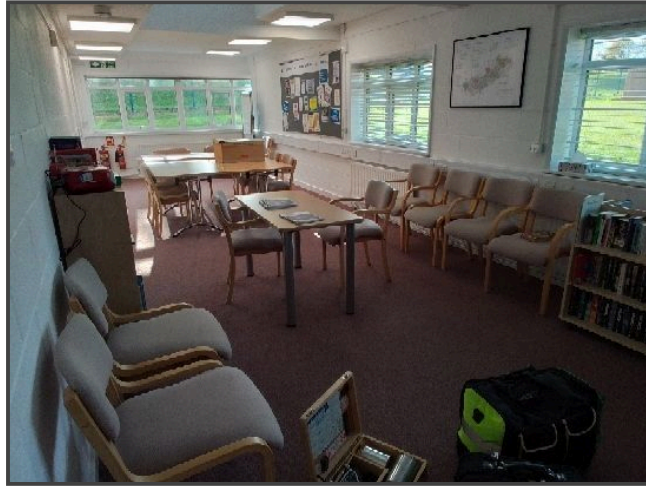
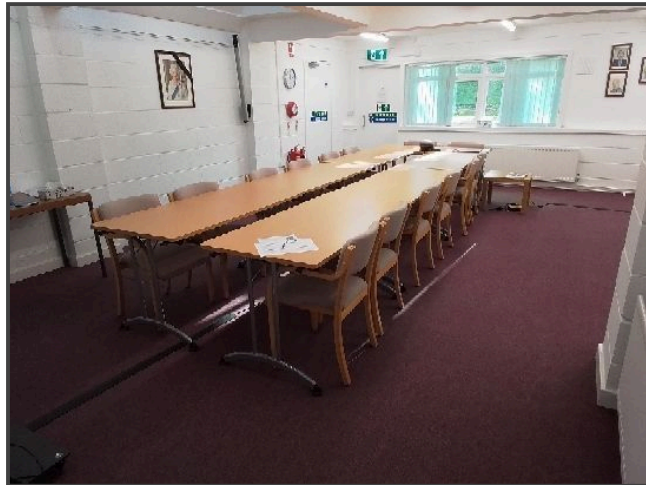
- Limited inspection possible due to fixed kitchen units, work units, bathroom units, bathroom tiles and stored items.

- There is visual evidence of salt banding on the internal and external walls.

Salt bands occur following a previous leak, and is a sign that the walls are drying out.

Rentokil are unable to categorically state the route cause of the moisture at this time.
